Safety Inspection Report

Annual Inspection

Play Area off Garden Road

Woolmer Green Parish Council

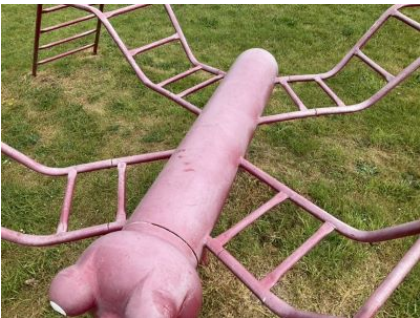
There is a head entrapment.

Small gaps where are less than 230 mm.

The unit was installed prior to the publication of the current standards. There is no requirement to make retrospective changes.

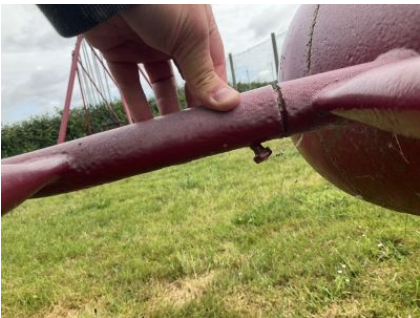
Hard or sharp projections.

Bolt head projecting.

Read the notes for further action.

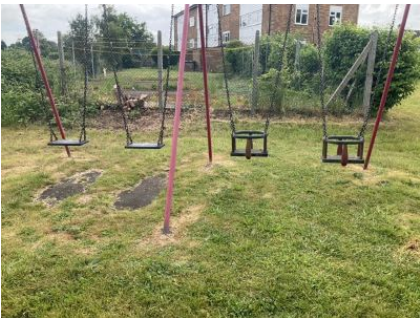
The distance between the seats is insufficient.

The unit was installed prior to the publication of the current standards. There is no requirement to make retrospective changes.

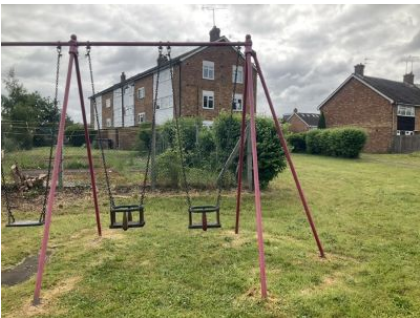
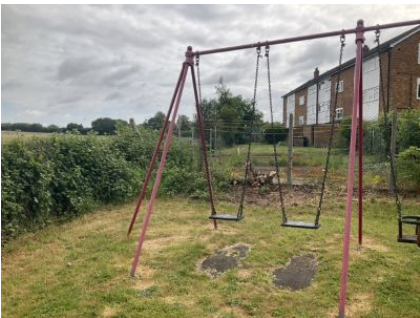
The distance between the seat side and the support is insufficient.

The unit was installed prior to the publication of the current standards. There is no requirement to make retrospective changes.

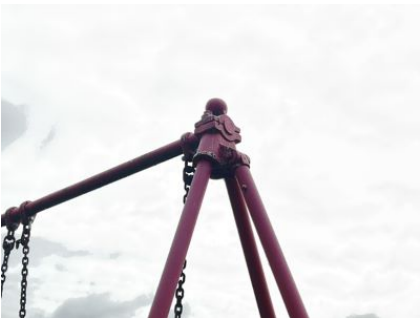
The manufacturer of this equipment advises that due to its age it cannot guarantee its stability and that the item should be removed.

Follow the manufacturer's guidance.

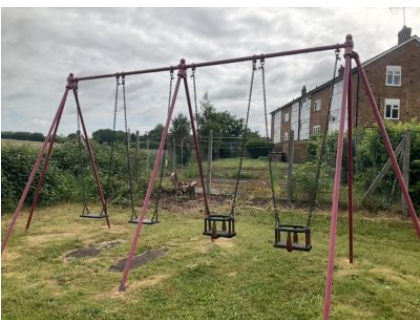
Bird fouling present.

Consider fitting an anti-bird strip or upward-facing cable ties to the top bar to prevent birds from landing,. It is recommended that playground equipment be regularly checked for bird fouling - if found, the affected items should be cleaned with a disinfectant solution.

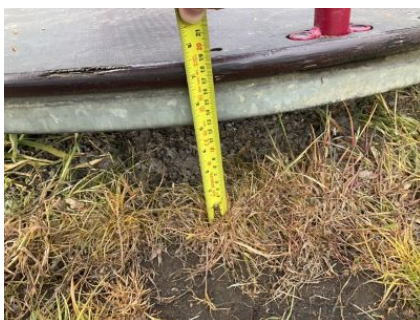
Clearance between the underside of the roundabout and the surface is incorrect.

Greater than 110 mm in areas.

Re-install roundabout or adjust surfacing. Recommended height 60-110 mm for 300 mm from edge.

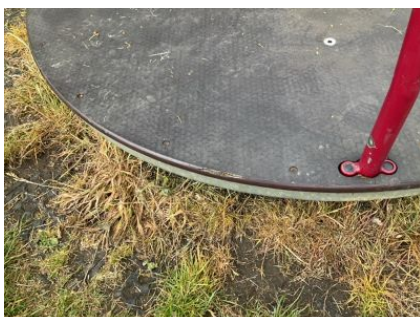
Laminate damaged.

Rub down and treat damaged edges.

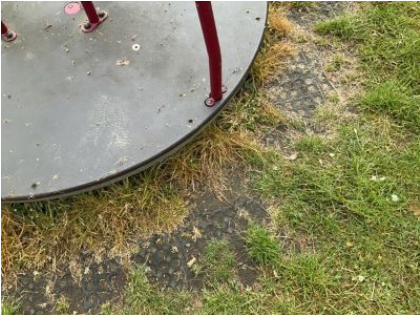
Item has some parts missing.

Matting sections. Replace.
Remove grass underneath unit.

Read the notes for further action.

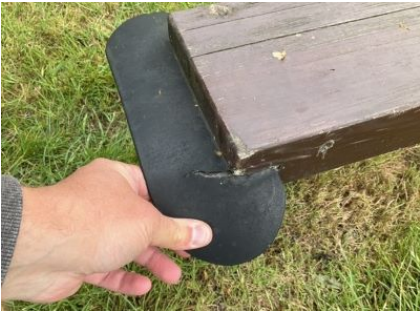
Item is damaged.

End rubber/s. Replace when necessary.

Replace.

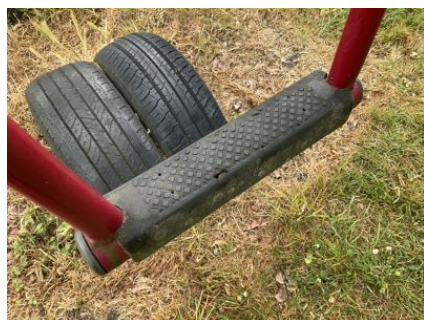
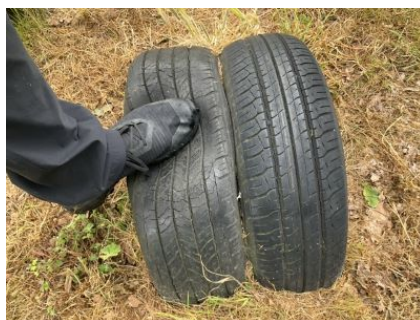
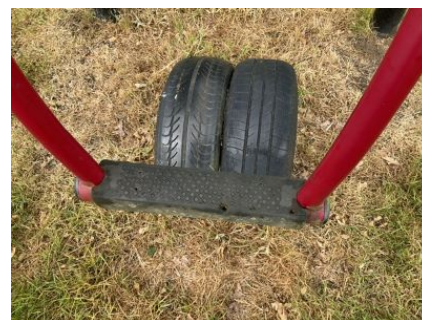
Item is worn.

Rubber foot holds and tyre dampeners. Replace in the near future.

Read the notes for further action.

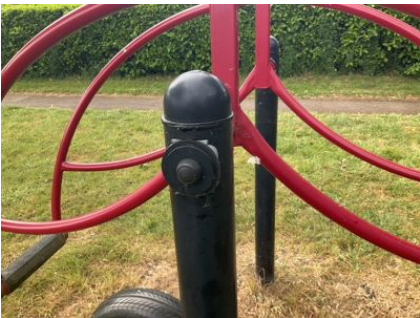
The supporting components should be dismantled and inspected according to the manufacturer's instructions. This will need doing on a regular basis, as defined by the manufacturer. This can lead to a high risk if no action is taken.

Noisy in operation.

Dismantle and inspect according to manufacturer's instructions.

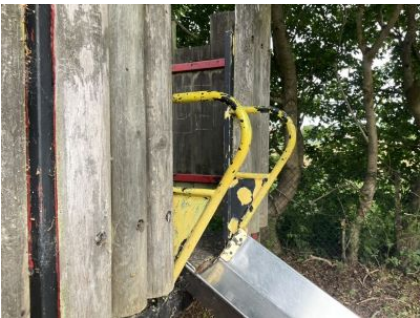
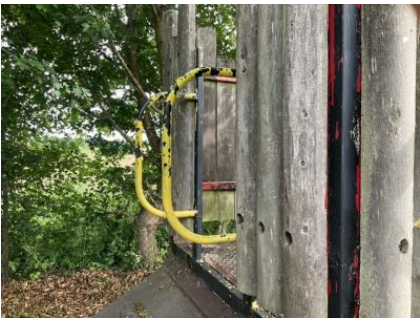
There is a head entrapment.

Slide and ramp hand rails.

The unit was installed prior to the publication of the current standards. There is no requirement to make retrospective changes.

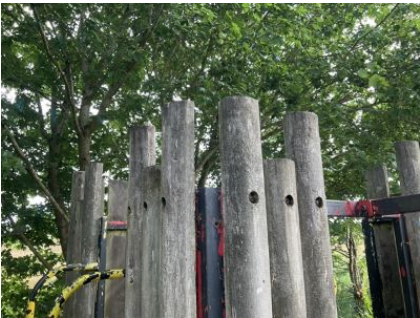
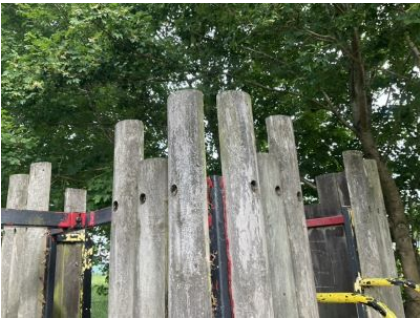
A head/neck entrapment is present in a partially bound opening.

Gaps at top of barriers.

The unit was installed prior to the publication of the current standards. There is no requirement to make retrospective changes.

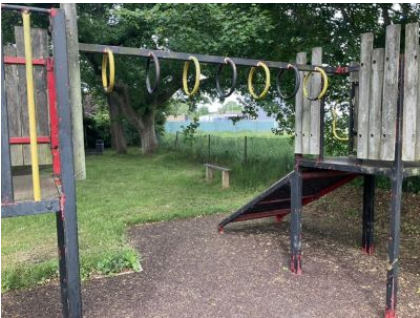
Overhead ladders and rings provide significant play value and benefits to children, and with it the risk of falling. Ensuring the surface remains in good condition will help to keep the correct balance between benefits and risk.

The protective surface under all bars and rings must be kept in good condition.

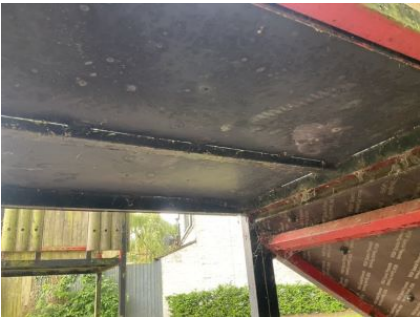
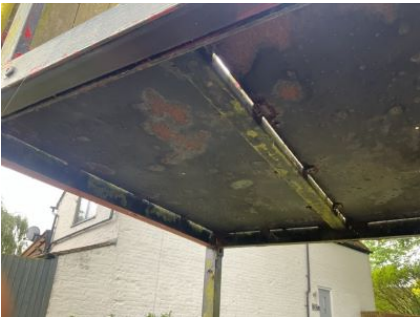
Item is rusting in places.

Platforms.

Descale.

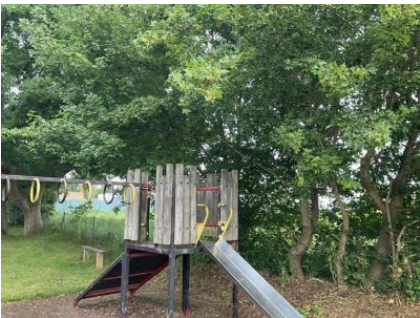
Overhanging tree branches are present.

Cut back.

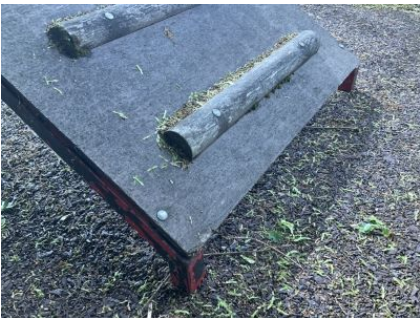
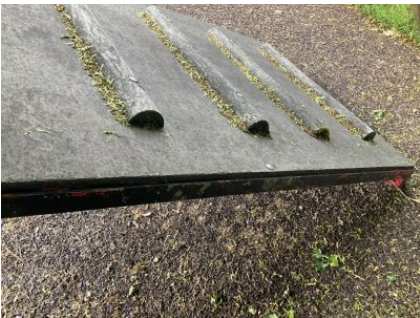
Laminate damaged.

Rub down and treat damaged edges.

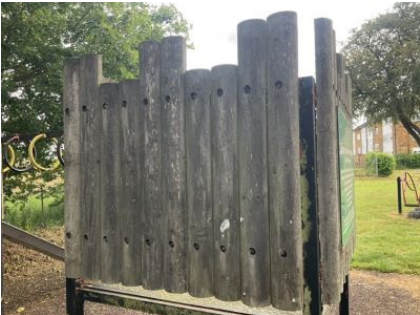
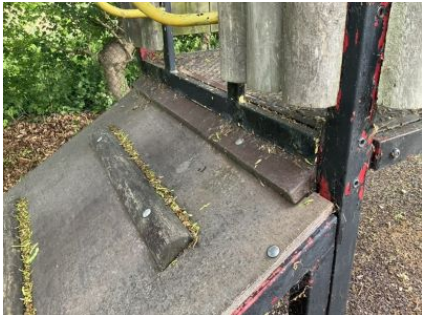
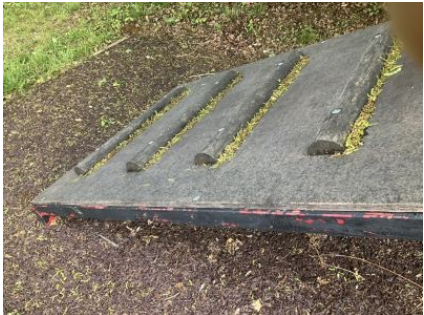
Bolt(s) loose.

Several barrier logs and ramp fixings are loose. Tighten.

Tighten.

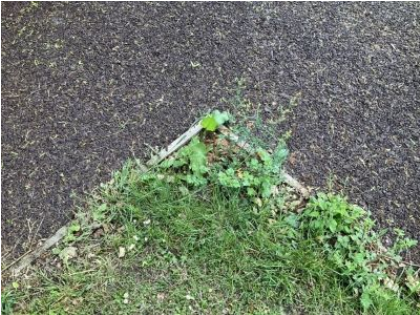
Trip points on the surface.

Around perimeters of unit. Build up ground levels and seed.

Build up surface level to remove trip points.
